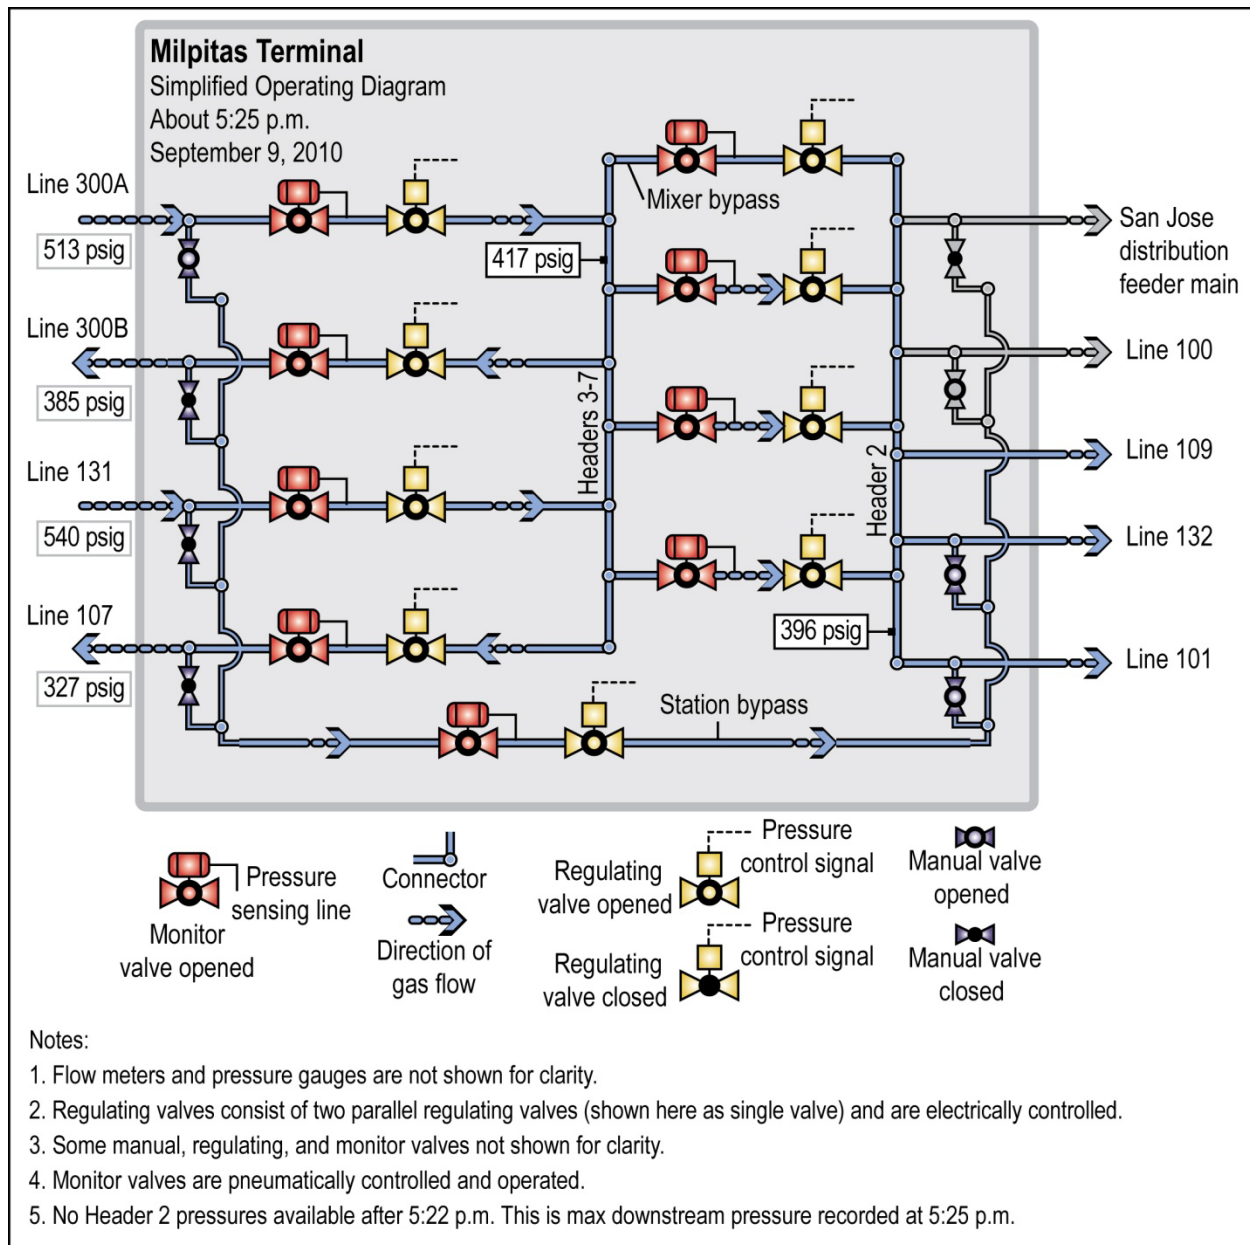
Figure 8b. Valve configuration at the Milpitas Terminal about 5:25 p.m.

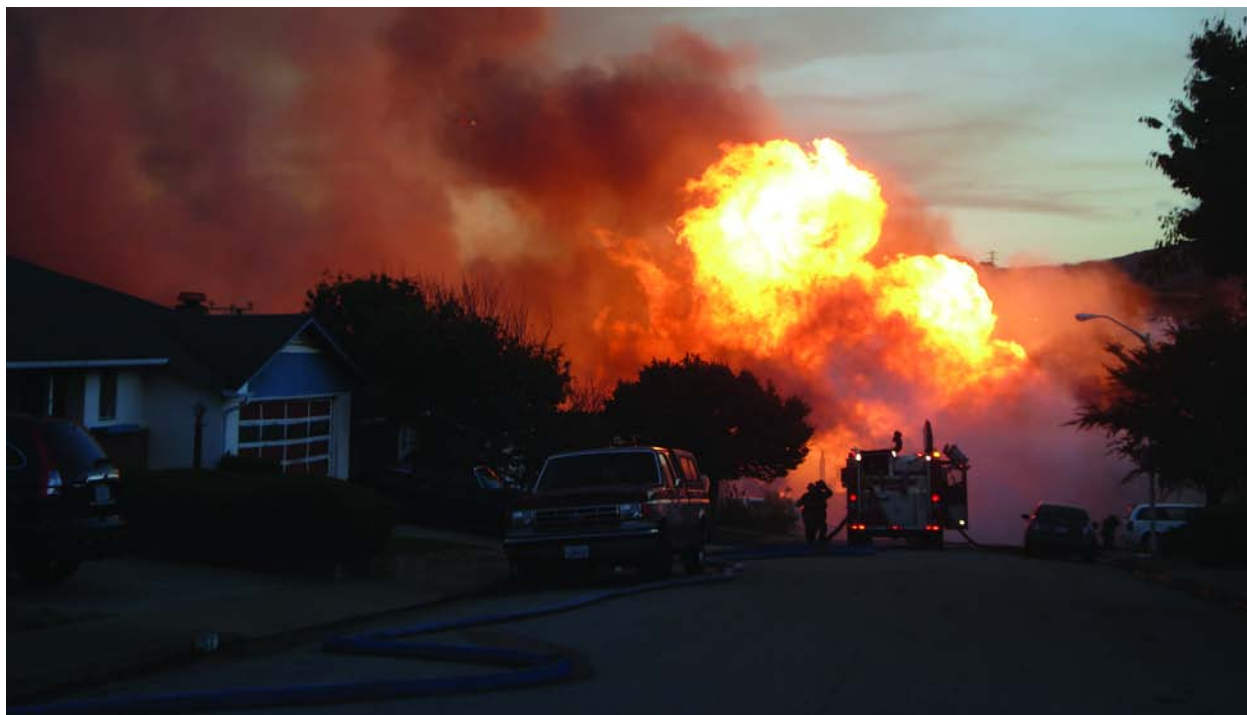
Figure 9. Firefighters approaching accident scene.

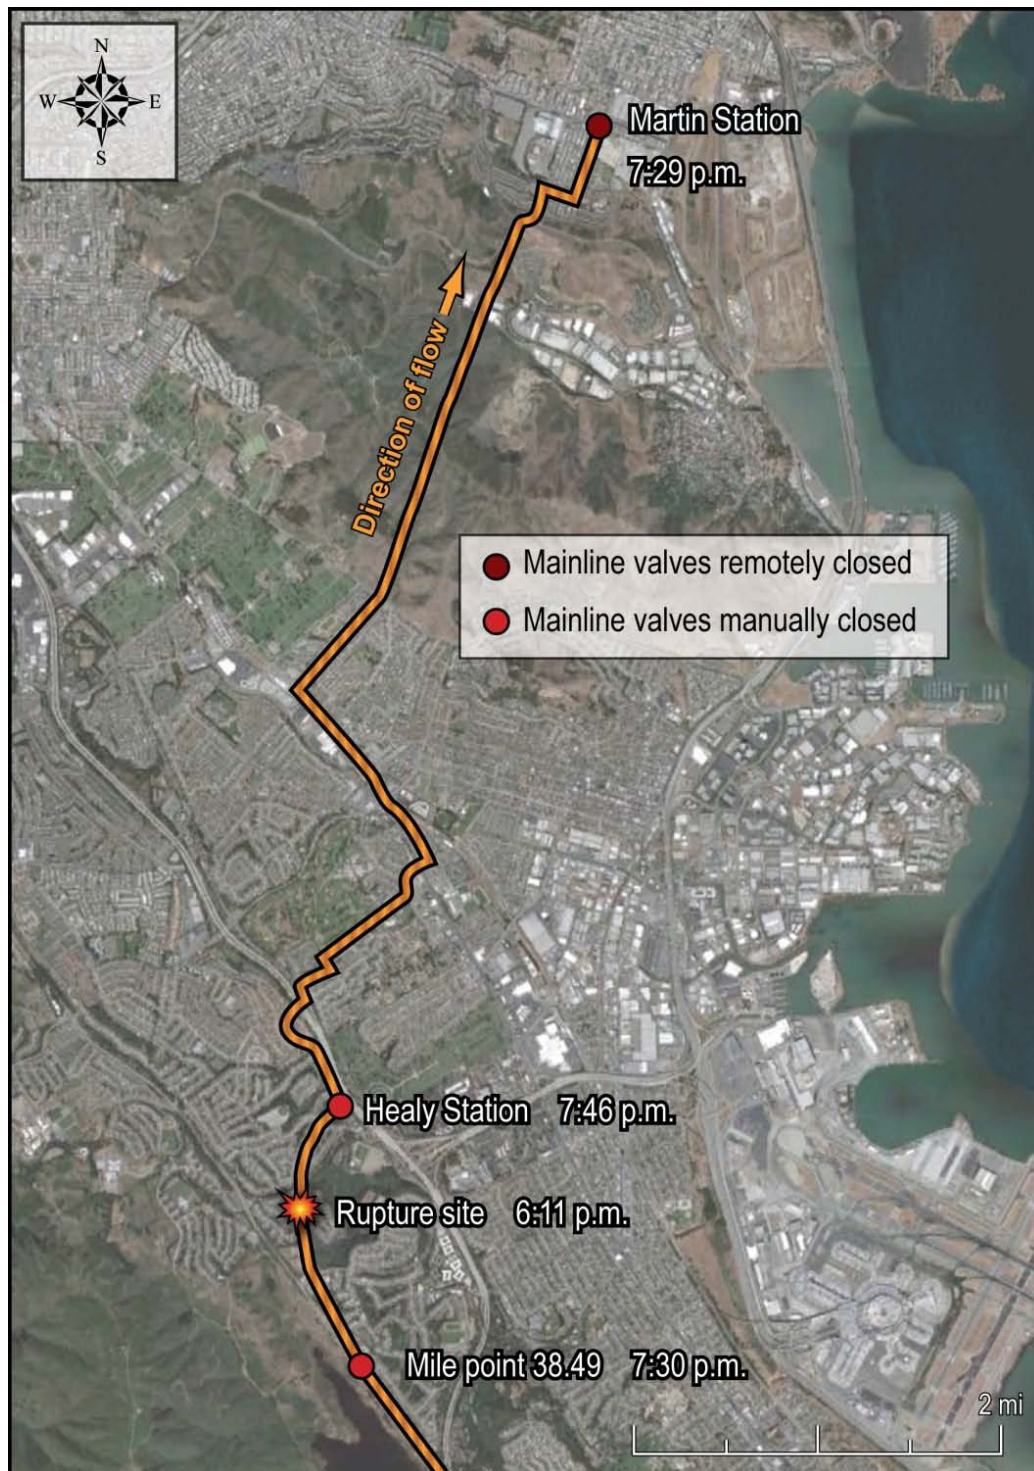
At 7:27 p.m., supervisor 6, who was with the two mechanics, requested that the SCADA center close two valves at the Martin Station. SCADA operator D remotely closed the valves downstream of the rupture by 7:29 p.m., which stopped the gas flow from north to south. (See figure 10.)

By 7:30 p.m., the two mechanics had manually closed the mainline valve (at MP 38.49) south (upstream) of the rupture, stopping the gas flow at that location. By 7:42 p.m., 91 minutes after the rupture, the intensity of the fire had decreased such that firefighters could approach the rupture site and begin containment efforts.

By 7:46 p.m., the two mechanics, with some assistance from supervisor 6, had manually closed two more valves downstream of the rupture (at MPs 40.05 and 40.05-2) at the Healy Station. Closing these valves isolated the ruptured section of pipe.

Figure 10. Location of valve closures.

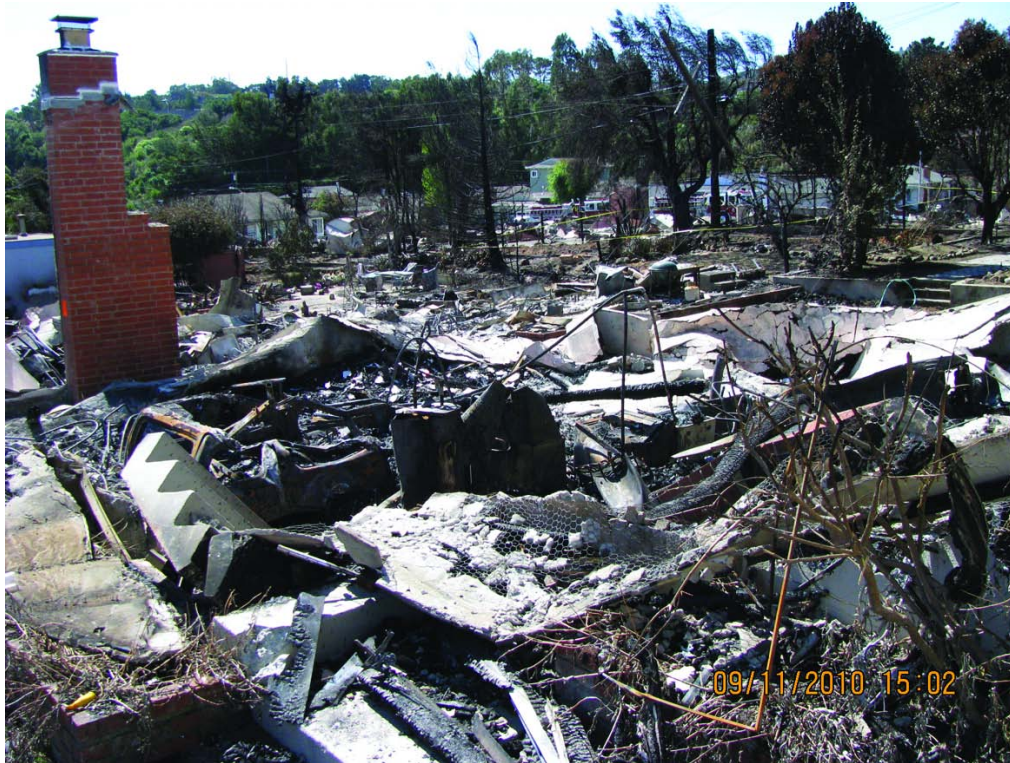
Figure 12. Picture of destroyed houses.

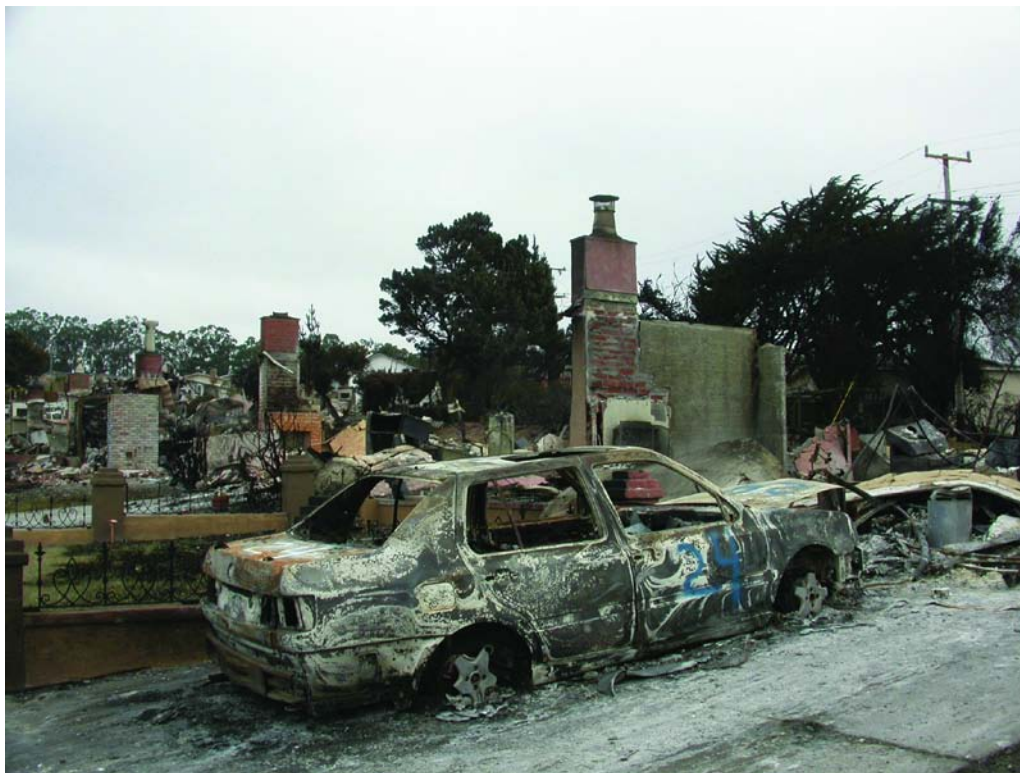
Figure 13. Picture of a burned car in front of several destroyed houses.

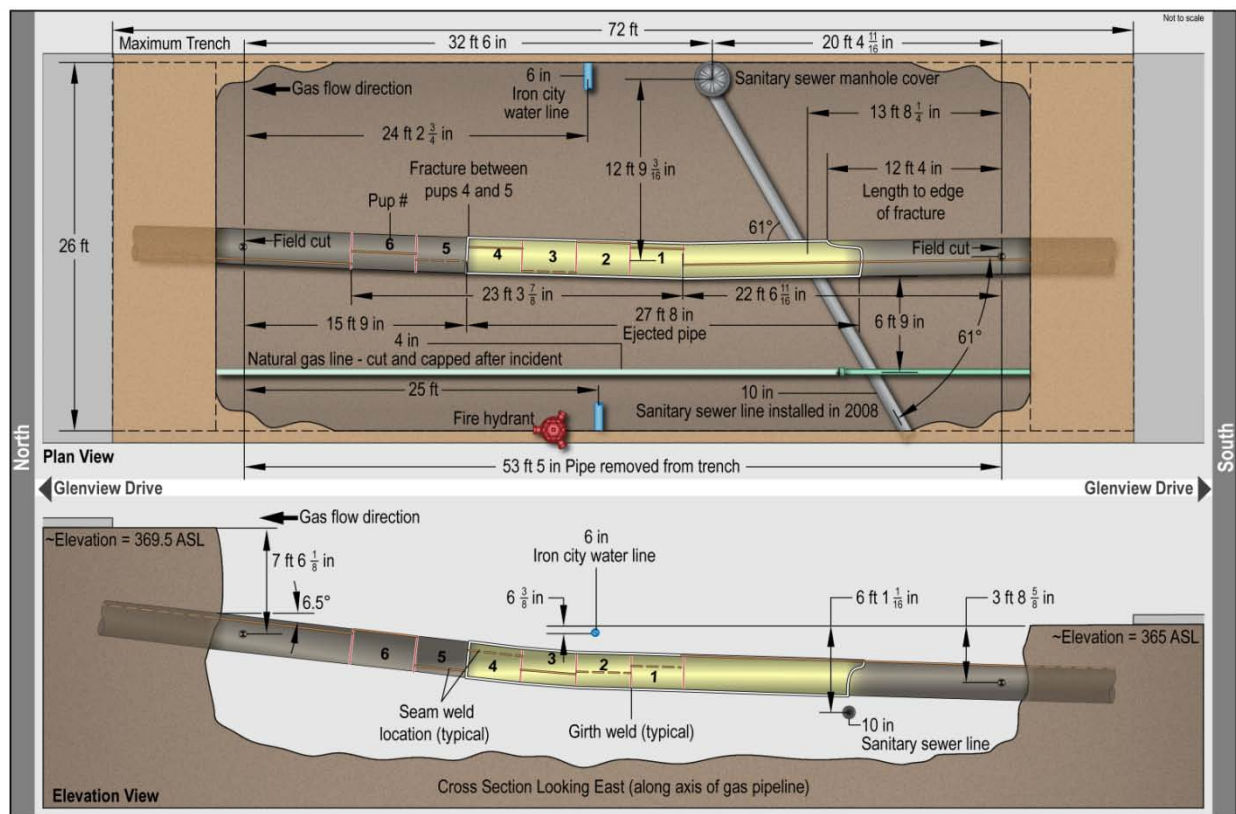
At the time of the accident, Line 132 was buried underground along the west side of Glenview Drive.⁴⁵ Other underground utilities at the accident site included a 6-inch-diameter water line, which crossed about 2.5 feet above Line 132 at the location of the rupture and was destroyed, resulting in the lack of functional fire hydrants near the accident scene. A 10-inch-diameter sanitary sewer line crossed below Line 132 about 108 inches south of pup 1. (The sewer line is discussed further below.) In addition, a 4-inch-diameter gas distribution line ran parallel to Line 132, about 6 feet 9 inches to the west. (See figure 16.) Farther below the buried utilities, at a depth of about 9 feet, was a drainage system with a catch basin running from west to east, which emptied into a canyon just east of the accident location.

Figure 16. Sketch of underground utilities environment.

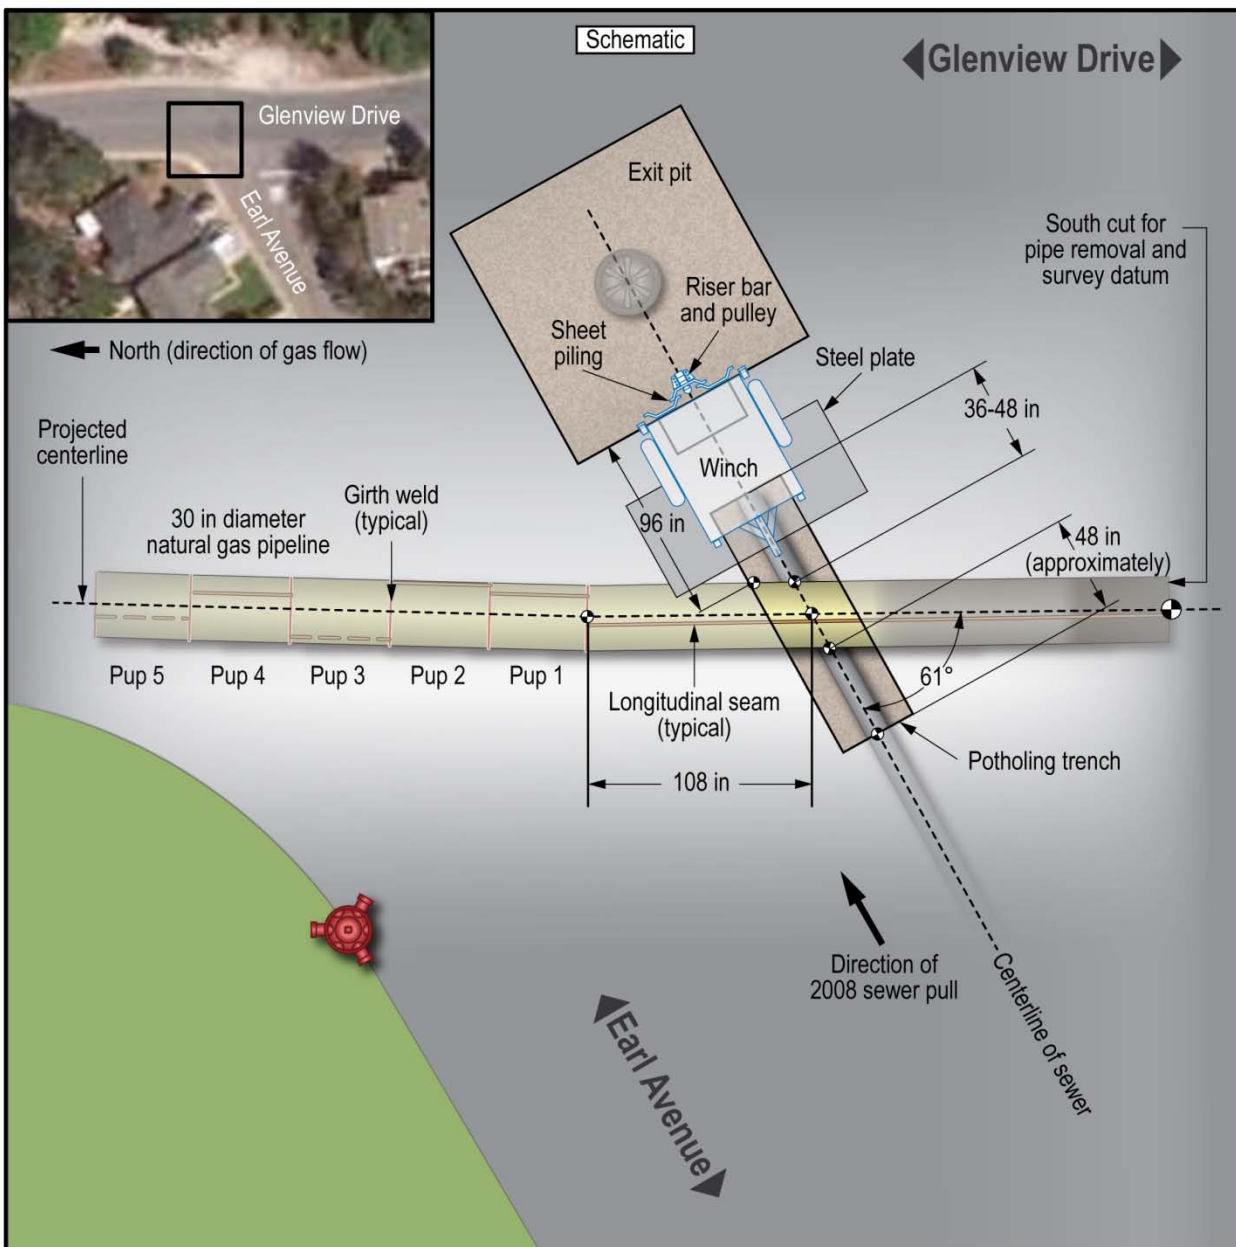
The pipe bursting began at the entry pit 290 feet to the west on Earl Avenue. A video of the project recorded the sound of the pneumatic bursting and showed the movement of the replacement pipe at the exit pit and the movement of the cable at the winch. Based on the recording, the pneumatic bursting rate was 214 strokes per minute. Based on the video, the replacement pipe pull rate ranged from 0.1–0.2 inches per second. According to the contractor, the maximum load on the winch was 14,000 pounds and the diameter of the cable was 0.562 inch. As the bursting head approached the potholing trench, the pneumatic device was turned off. From there, the replacement sewer pipe was pulled through the potholing trench, underneath Line 132, and up to the exit pit. (See figure 17.)

Figure 17. Diagram of excavations relative to Segment 180.
